# Manhole Inspection Summary

Manhole # S53M\_\_019MH

Insp Date: **9/14/09 11:52 AM**

**Location** Address: **3025 Hudson St.**

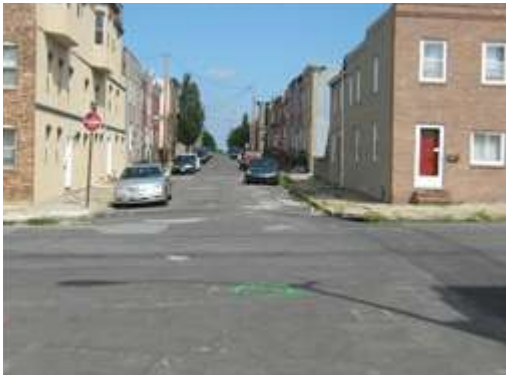
Location View

View facing north

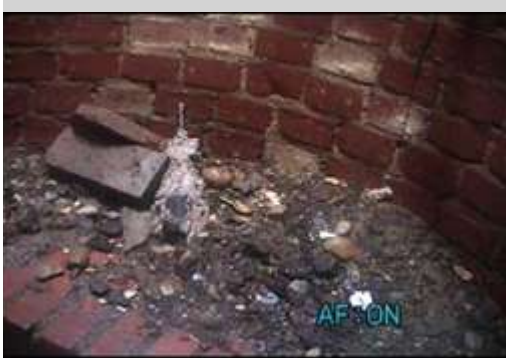
Miscellaneous

debris on the bench

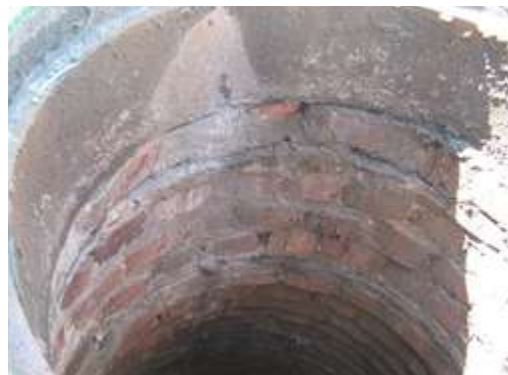
Defect 4

Infiltration: ☐ None ☒ **Joint** ☐ Cracks ☒ **Mortar** ☐ Roots ☐ Wall

chimney infiltration from joint and/or mortar

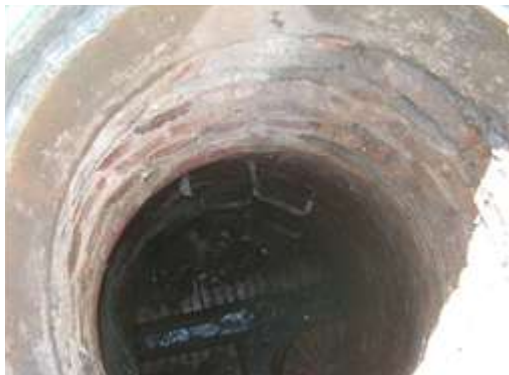
### Defect 3

Missing: **2**

☒ **Corroded**

missing and corroded rungs
